Manhole Inspection Summary

Manhole # S45W__013MH

Insp Date: **5/28/09 12:12 PM**

Location Address: **1300 ANDRE ST.**

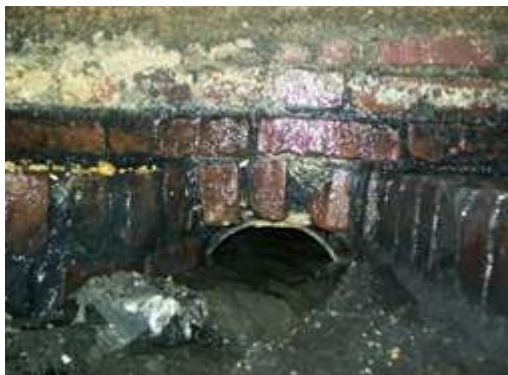
Defect 4

Condition: ☐ Sound ☐ Cracked ☐ Root Intrusion ☐ Deteriorated ☐ Leaks ☒ **Debris**

channel debris

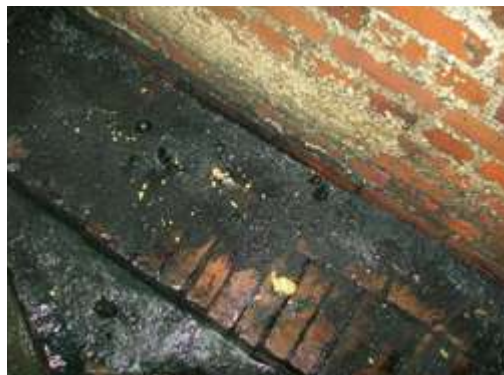
Defect 5

☒ **Evidence Of Surcharge** Depth: **0** (ft.) ☐ Active Surcharge Present

WALLS: EVIDENCE OF SURCHARGE

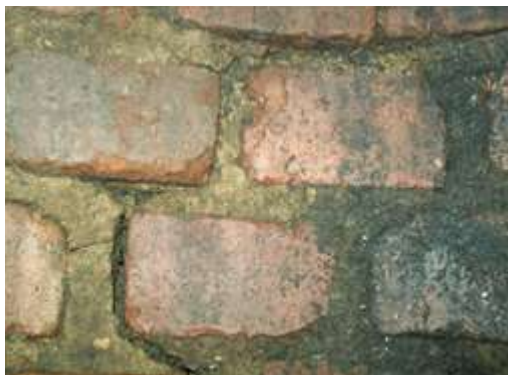
Defect 3

Condition: ☐ Sound ☒ **Cracked** ☐ Root Intrusion ☐ Loose Brick ☐ Deteriorated

CORBEL CRACKED BRICKS

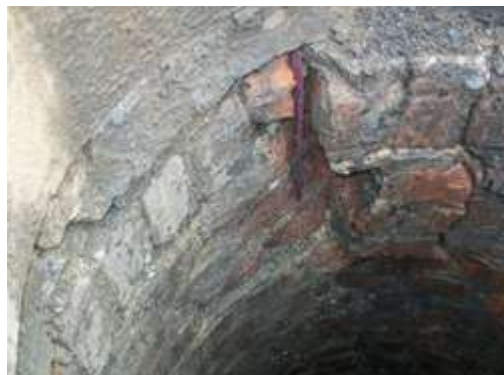
Defect 2

Condition: ☐ Sound ☒ **Cracked** ☐ Root Intrusion ☒ **Loose Brick** ☐ Deteriorated

chimney cracked

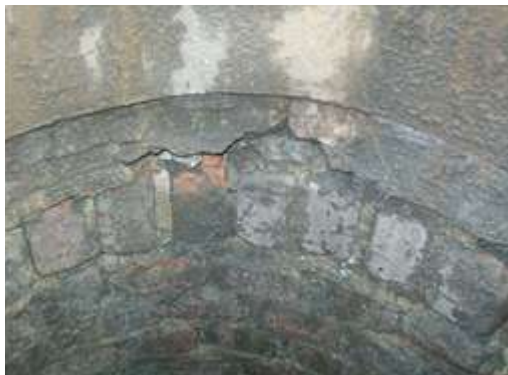
Defect 1

CHIMNEY LOOSE/MISSING BRICKS

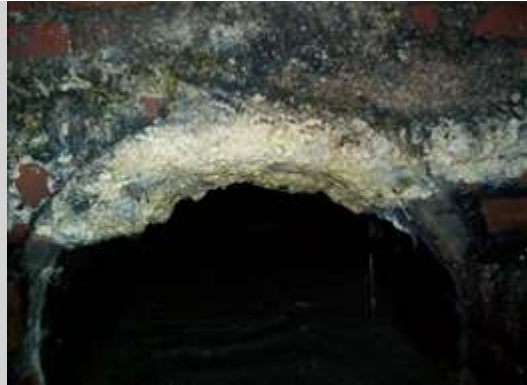
12 O'Clock Outflow

24 in. Circular Gravity Sewer
Pipe Out @ 12 O'Clock

Pipe Height: **24** (in.) Rod and Bar (Angled)
Pipe Material: **Clay** ☐ Pipe Lined
Invert Depth: **14.92** (ft.) Flow Characteristics: **Fast**
Deposits: ☐ None ☐ Mud ☐ Sludge ☐ Debris ☒ Grease
Silt Depth: **3** (in.) Deposits Extent: **Medium**
Infiltration: **None** Pipe Seal Cond: **Sound**

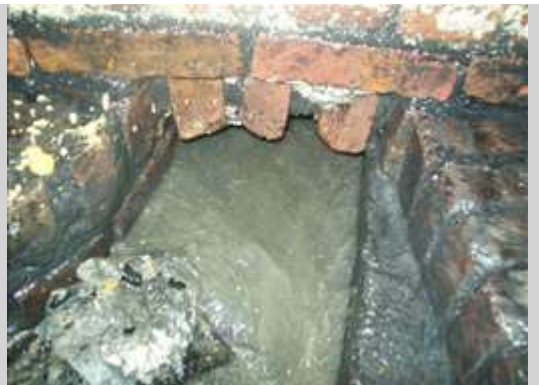
3 O'Clock Inflow

10 in. Circular Gravity Sewer
Pipe In @ 3 O'Clock

Pipe Height: **10.8** (in.) Rod and Bar (Angled)
Pipe Material: **Clay** ☐ Pipe Lined
Invert Depth: **14.67** (ft.) Flow Characteristics: **Fast**
Deposits: ☐ None ☐ Mud ☐ Sludge ☒ Debris ☐ Grease
Silt Depth: **6** (in.) Deposits Extent: **Medium**
Infiltration: **None** Pipe Seal Cond: **Cracked**

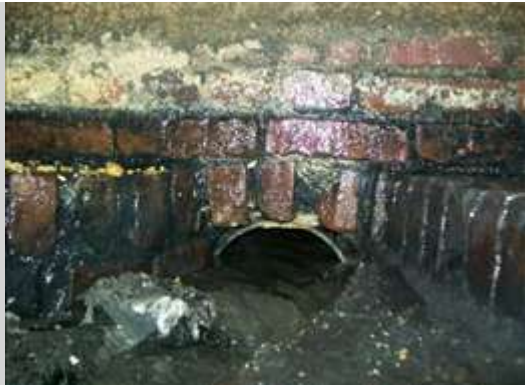
9 O'Clock Inflow

12 in. Circular Gravity Sewer
Pipe In @ 9 O'Clock

Deposits: ☐ None ☐ Mud ☐ Sludge ☒ **Debris** ☐ Grease

Silt Depth: **4** (in.) Deposits Extent: **Heavy**

Infiltration: **None** Pipe Seal Cond: **Cracked**
